# **D8.6 - DEVELOPING RESILIENCE- ENABLING INTERVENTIONS IN CULTURAL HERITAGE BUILDINGS, URBAN AND RURAL CONTEXTS - APPLICATION TO A REAL DEMO**

SEPTEMBER 2025 | UNIVERSITY OF MINHO

| Deliverable | D8.6 - Developing resilience-enabling interventions in cultural heritage buildings, urban and rural contexts - Application to a real demo |
| Main Authors | Mónica Santamaria (UMINHO), Hijratullah Sharifzada (UMINHO), Ilaria Ingrosso (RINA-C), Luca Urciuoli (KTH), Ari Prasetya (KTH), Juan Aguilar Lopez (TUDelft) |

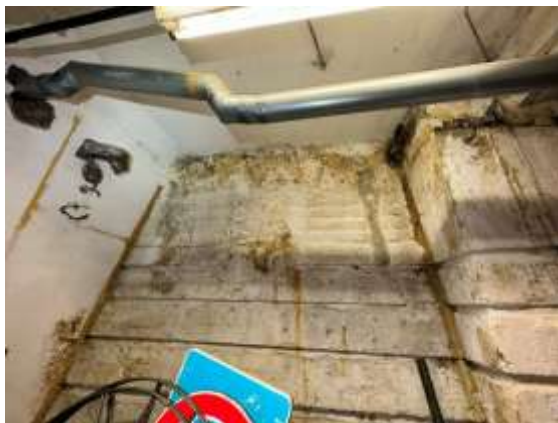
a) Cast concrete foundation structure

Based on the damages identified in the technical inspection report, the basement and foundation are primarily vulnerable to moisture infiltration and localized structural deformations. However, the overall structural condition of the foundation is considered satisfactory, as the existing damages do not currently compromise the mechanical strength and stability of the building. Nonetheless, the presence of cracks in the load-bearing walls requires continued monitoring to help determine whether structural reinforcement is needed to mitigate the effects of foundation deformations and soil instability. Additionally, intervention measures are needed to improve surface water drainage and prevent further moisture infiltration, particularly in areas where incomplete concrete sealing of former lightwells has led to water ingress. Restoration of the protective kerbs, including pavestone and asphalt pavement repairs, are also necessary to ensure effective drainage and minimize soil leaching near the foundation.

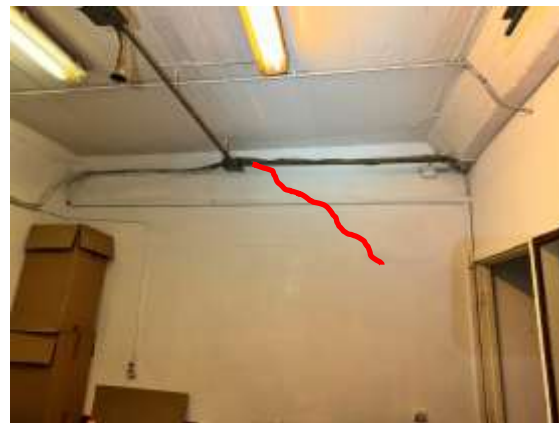
b) Diagonal cracks in basement walls

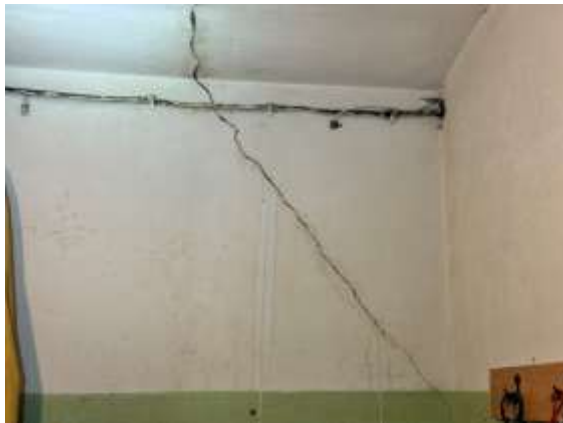
c) Diagonal cracks in the stairwell wall extending from the expansion joint in the slab

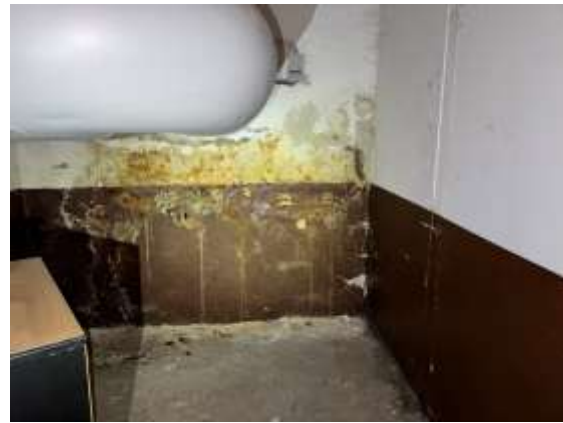
d) Damage due to prolonged moisture saturation in the basement walls of the building

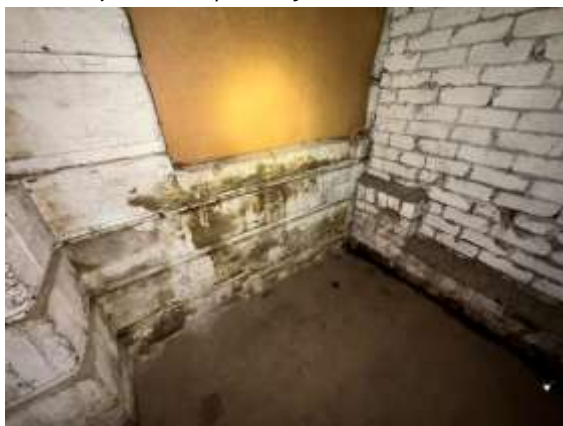
e) Moisture penetration into the basement through the old lightwells.

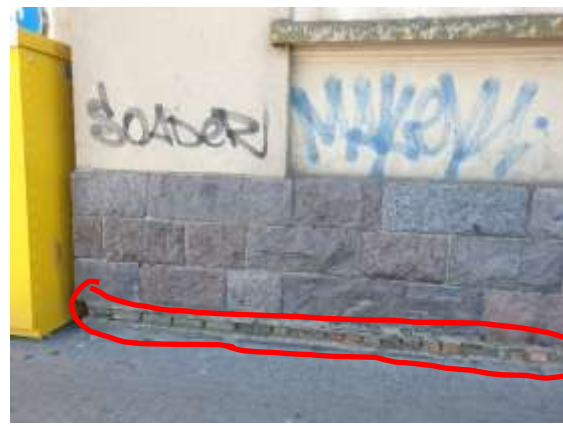
f) Damage in the plinth of the building potentially allowing moisture penetration into the basement

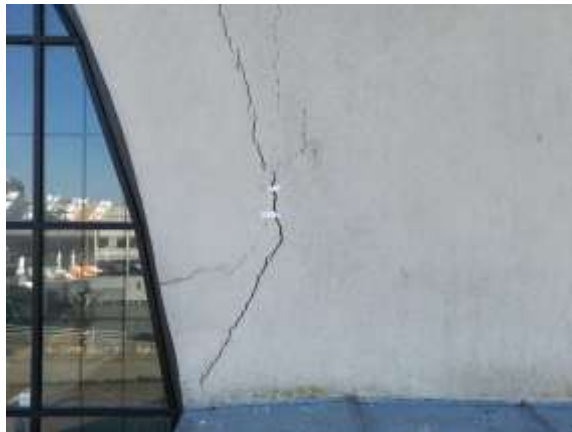
a) Cracks in the arched lintel - north side of the building

Based on the damages identified in the technical inspection report, the load-bearing walls and arch lintels are primarily vulnerable to deformations resulting from insufficient anchoring between the reinforced concrete lintels and the masonry wall, as well as the weakening effect of ventilation shafts. However, their overall structural condition is deemed satisfactory, as the extent of the cracks at the identified locations indicate a local structural problem, which does not currently compromise the mechanical strength and stability of the building. To prevent further deterioration and cracking of the finish, it is necessary to develop and implement a strengthening and anchoring solution for the arch lintels, ensuring that further settlement is prevented.

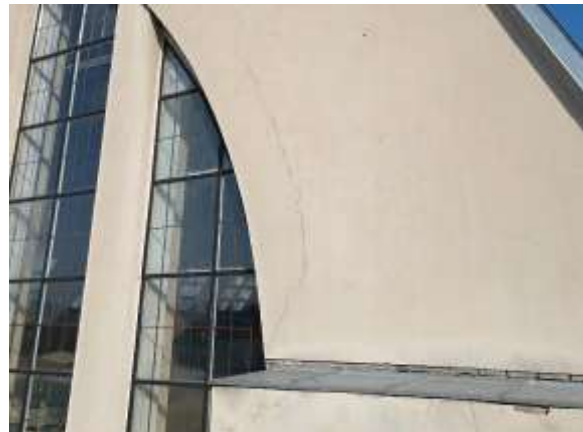
b) Cracks in the arched lintel - south side of the building.

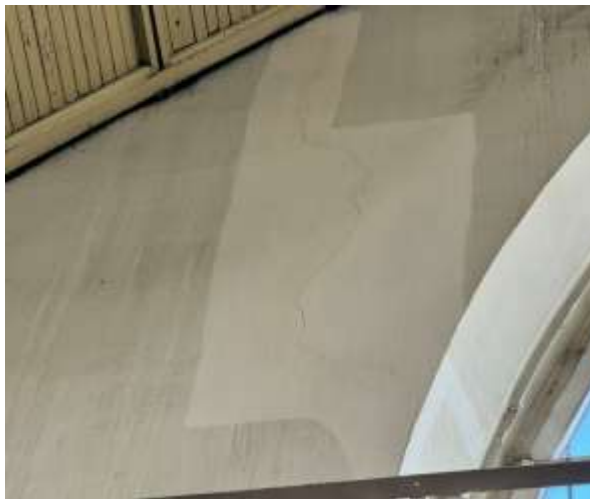
c) Cracks in the arched lintel (on the inside) with renovated finish - north wall of the building

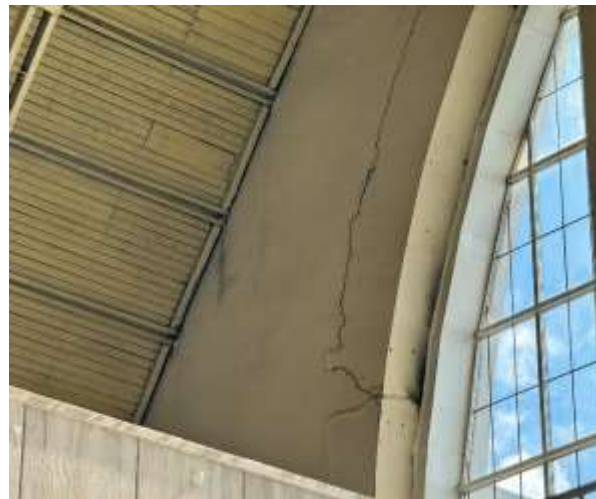
d) Cracks in the arched lintel (on the inside) - south wall of the building

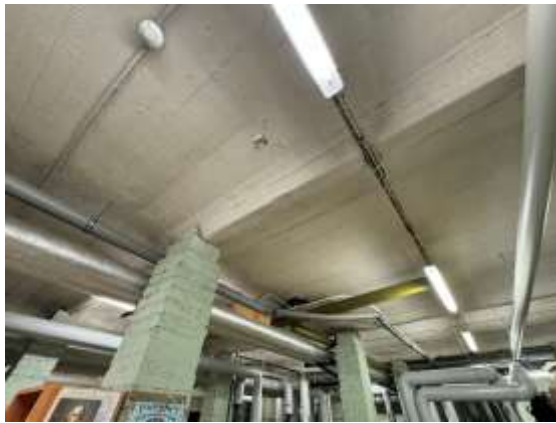
a) Reinforced concrete slab and column connection in the basement

Based on the damages identified in the technical inspection reports, the basement slab is primarily vulnerable to moisture infiltration, corrosion of reinforcement bars and potential overloading. Although the overall structural condition is deemed satisfactory, it is necessary to implement mitigation measures to prevent further moisture migration from the first floor to the basement (e.g., by properly sealing the expansion joints), treat the corroded reinforcement bars, and repair the concrete surfaces. The implementation of these measures must be carried out before constructing the planned new floor structure to install UPONOR's energy solution (refer to Deliverable 3.3 (Luprano et al. 2024)). Moreover, lightweight materials, such as expanded clay concrete, are recommended during the floor modifications to prevent excessive additional loads on the slab.

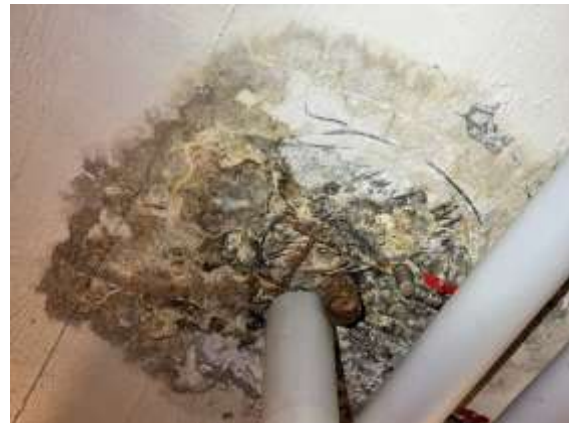
b) Moisture damage in the basement slab with corroded reinforcement

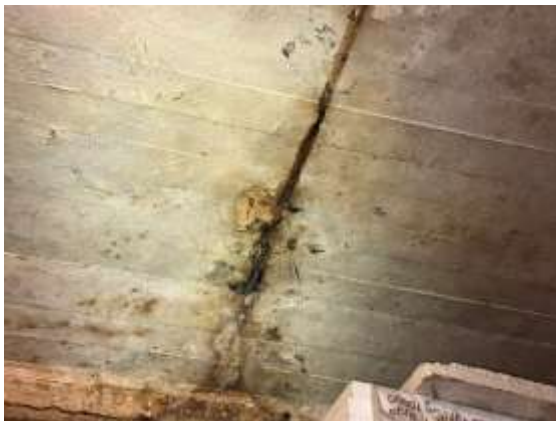
c) Expansion joint in the concrete slab, aligned in the N-S direction.

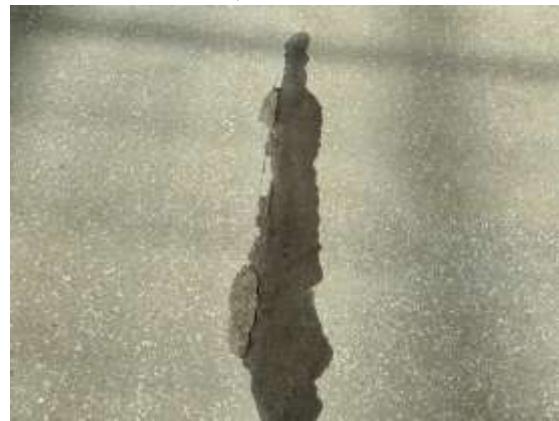
d) Floor cracks and surface layer chipping on the first floor

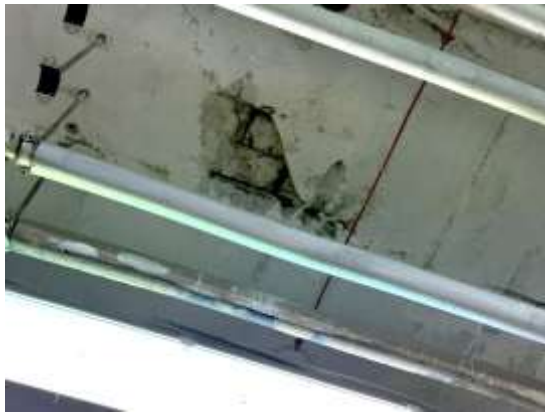
e) Locally corroded slab reinforcement with spalling of concrete

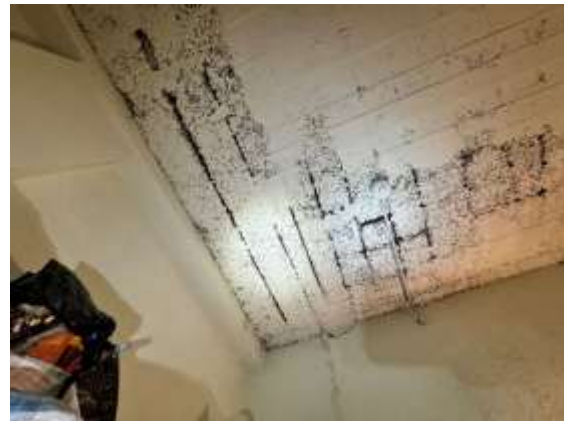
f) Exposed reinforcement due to poor concrete compaction during construction

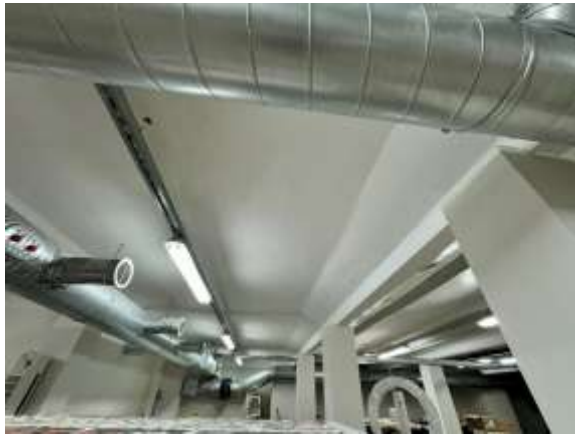
a) Frame structure in the basement: masonry columns supporting steel beams

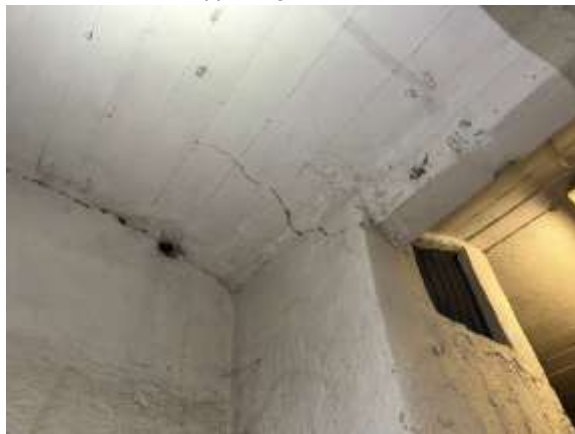
c) Cracking in the slab and foundation walls at the support of steel beams

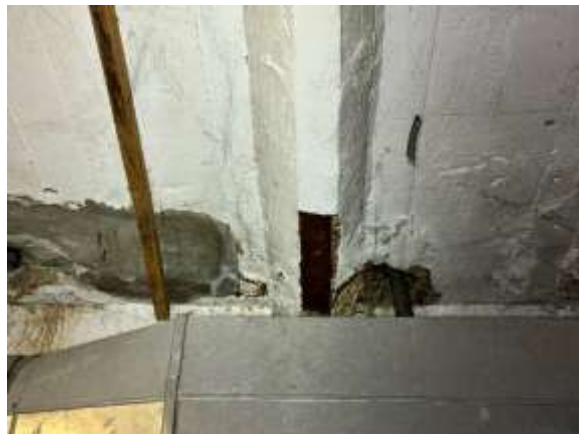
d) Corroded steel beam causing delamination of the protective concrete layer

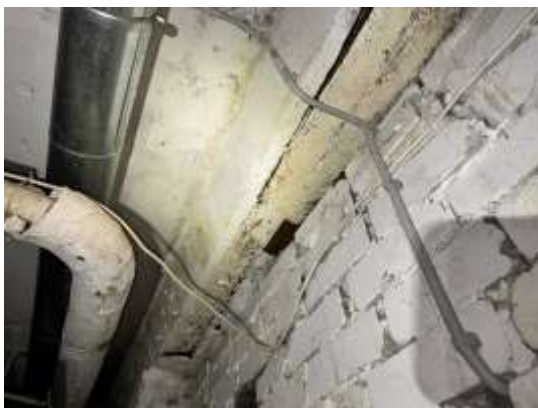
e) Corroded steel beam causing delamination of the protective concrete layer

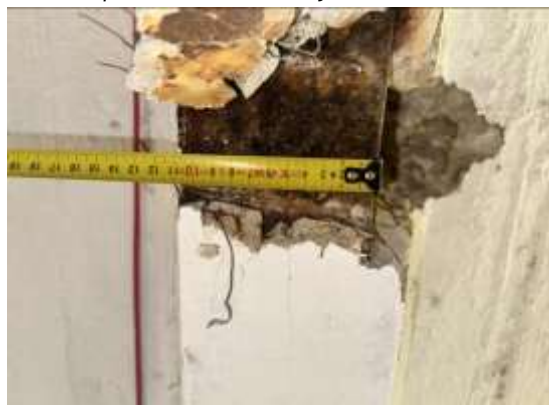
f) Superficial corrosion damage in the bottom flange of the steel beam

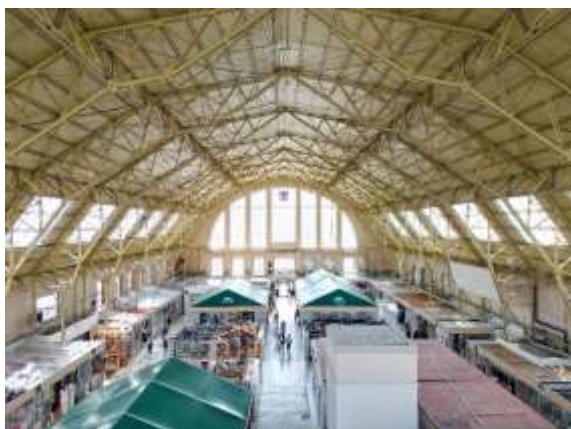
a) Roof structure - steel trusses

Based on the damages identified in the technical inspection, the roof structure is primarily vulnerable to deformations due to inadequate load-bearing capacity of certain truss members, overloading, and moisture-related deterioration. The damage in the ridge truss members is particularly critical, as loss of strength in these components shifts additional loads onto other truss elements, increasing the risk of overloading. In fact, the technical inspection report assessed the overall condition of the roof structure as unsatisfactory (Peredistijs 2024). To address these issues, a structural analysis of the roof trusses under actual operating loads must be performed to verify their load-bearing capacity, and a reinforcement solution for the damaged ridge truss elements must be developed and implemented. Additionally, repairs are required at the points where precipitation moisture infiltrates the roof, particularly at the roof window joints and the areas adjacent to the chimney, to prevent further deterioration of both the wooden and steel elements of the structure.

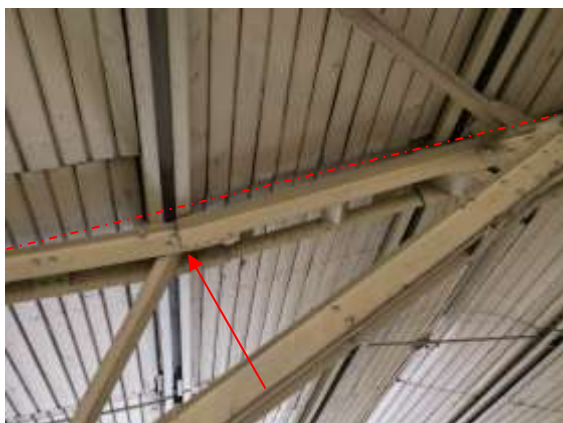
g) Locally replaced sections of the upper truss where the roof has settled

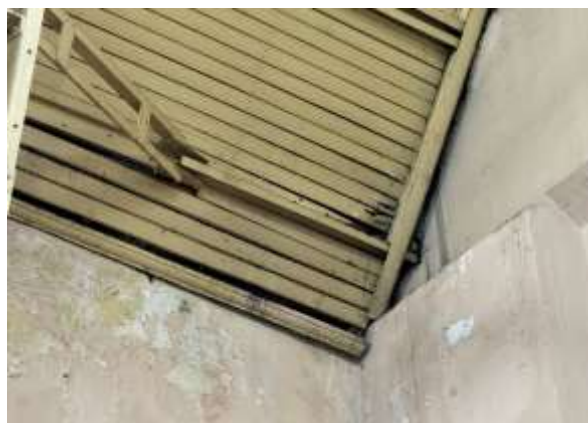
h) Wooden plank ceiling with signs of precipitation moisture infiltration

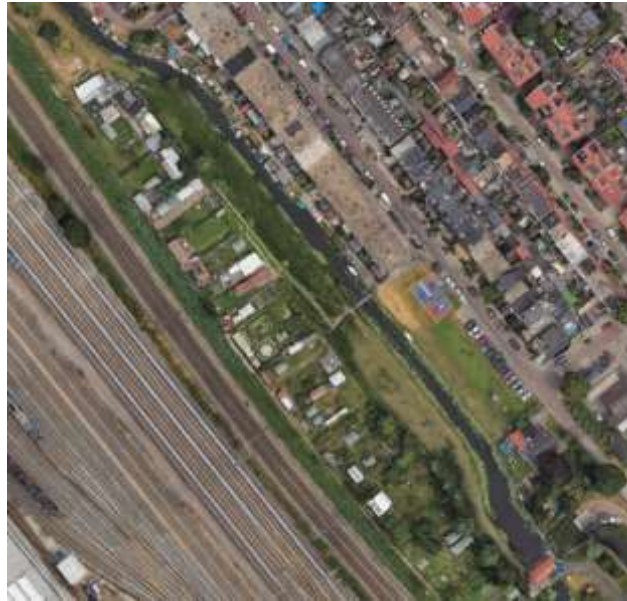
Figure 18. Overview of the Tedingebroekpolder dike and its flood defence system

Historically, it relied on windmills (e.g., Westmolen and Oostmolen) and later steam and electric pumping stations to manage inland water levels. The MULTICLIMACT Demonstrator in this area consists of the development of a fiber optics-based monitoring system for soil dikes and movable barriers. In the case of the Tedingebroek polder dike, the demonstrator flood defence protects the flood-prone area over the east side from an eventual flood derived from a dike breach event along the canal (See figure below) that drains the pumped water by the electric pump II A located in the Kortelandseweg (Red roof structure at the end of the channel in the lower right side of image). The Tedingebroekpolder, being a low-lying peat polder, is particularly susceptible to flooding if a dike fails while having elevations as low as -2 meters below sea level. Its proximity to urban areas like The Hague and one of the national railway maintenance workshop locations, increases the potential impact in terms of not only monetary costs but interruptions to the regular operation of national railway systems.

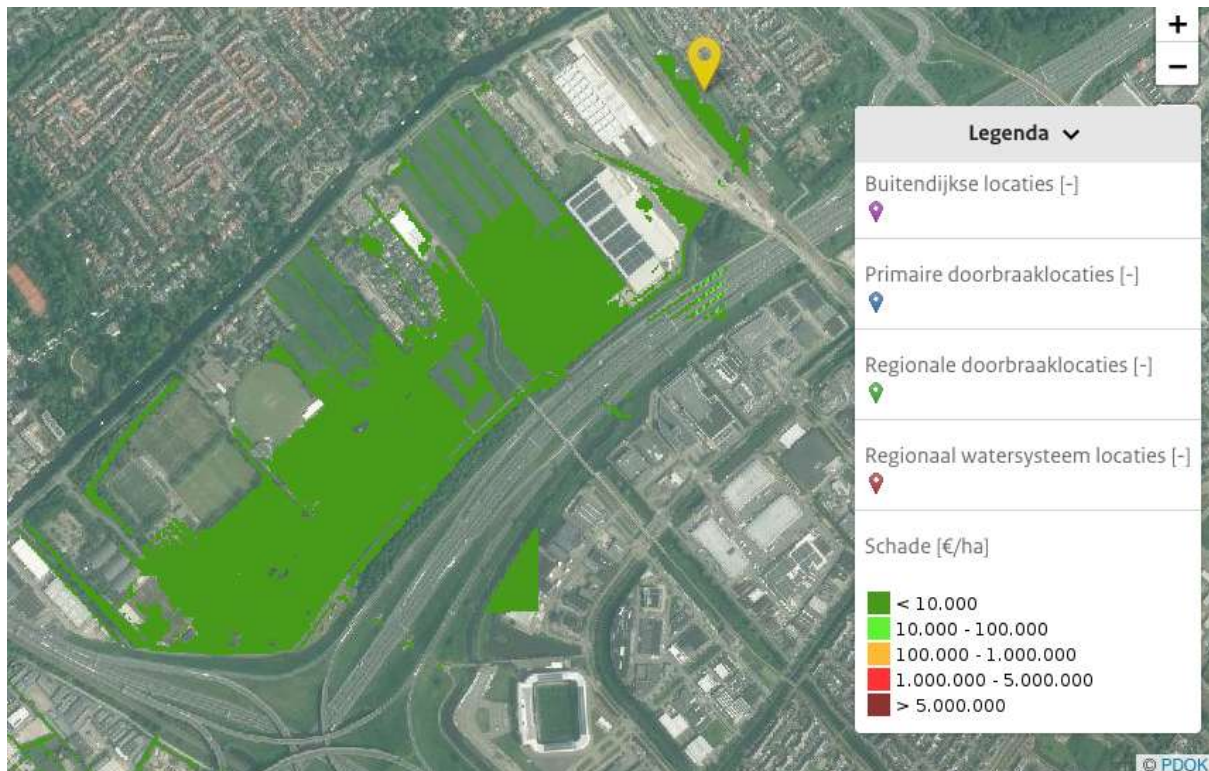
Figure 20. Damage Estimation Based on Simulated Flood Depths, Showing Expected Monetary Damage Below €10,000 per Hectare and Total Estimated Damage of €19 Million per Year.

For the same event, based on damage estimation curves produced by the Dutch government based on land use and cadaster estimations, the simulated water depths are later used as input so that the expected monetary cost of damages is calculated for the same resolution. The results are shown in the next Figure 20, and it can already be seen that the maximum value for this vent is below 10k Euros/ha. It can also be noted that the damage raster file was also arbitrarily clipped by the system, so squared trims are observed in the damage of the lower south area just below the highway.

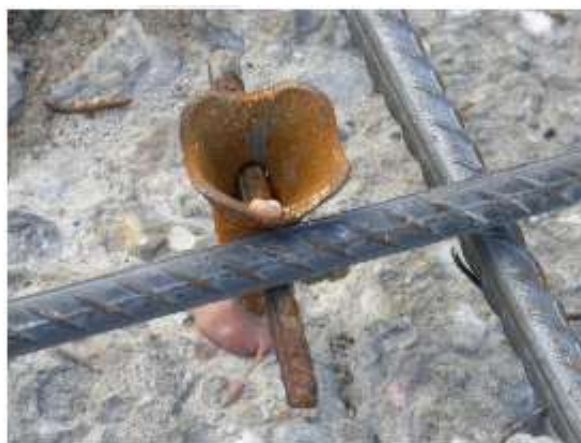
Figure 24. Cup-shaped connectors serving as reinforcement support (source: Júlio *et al.*, 2022a)

To ensure full load transfer between the existing concrete and the overlay (a monolithic behavior), intersecting reinforcement or mechanical connectors must be installed through the interface. These connectors are particularly necessary when adhesive bonding alone does not provide sufficient shear transfer. According to the European Standard EN 1504-10 (CEN, 2017), mechanical anchorage of new reinforcement into existing concrete can be achieved by installing steel bars into drilled holes using cement-based or synthetic resin bonding materials. These anchoring systems must achieve a minimum pull-out capacity of 75 kN at a displacement of 0.6 mm. The installation process requires rotary percussion drilling equipment, compressed air or vacuum cleaning tools, and injection guns or pumps for introducing bonding grout or resin into the holes for anchoring the connectors. The connector system may include cup-shaped heads (see Figure 24) optimized to introduce loads from the overlay and serve as support for the reinforcement layers, which also facilitate proof loading and placement checks (Júlio *et al.*, 2022a).

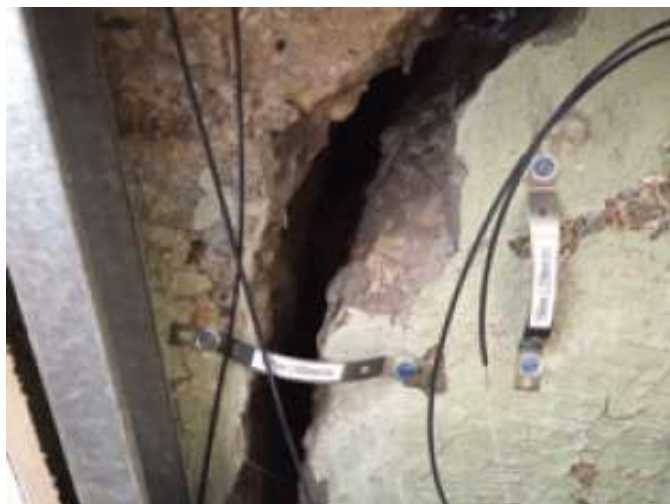
Figure 26: Example of FBG crack sensors applied to cracks.

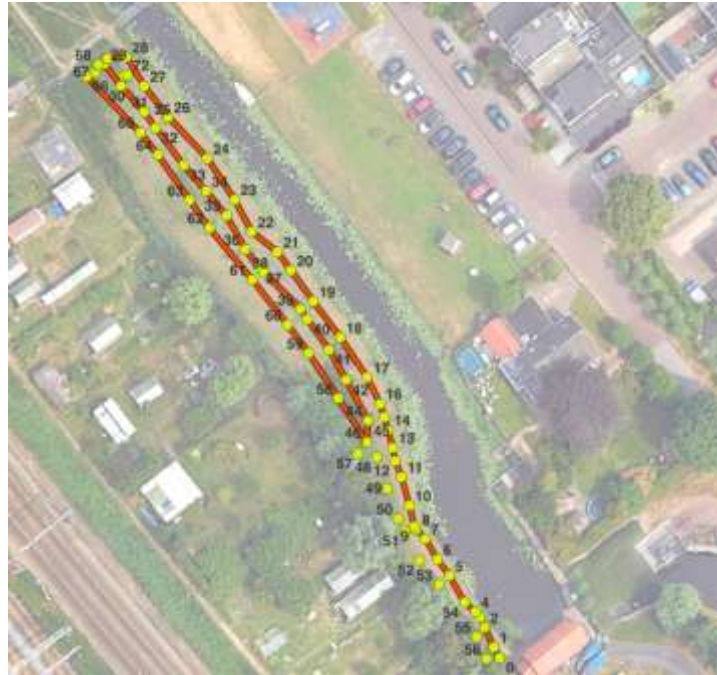
Figure 32. Aerial view of Tedingerbroek dike and the mapped location of the embedded fiber optic cable. Source: (Aguilar-López, Nöter, and Inghosso 2024)
